Death in the line of duty...

A summary of a NIOSH fire fighter fatality investigation

June 12, 2013

Volunteer Fire Fighter Struck and Killed by Backing Fire Apparatus at Rural Brush and Structure Fire – Illinois

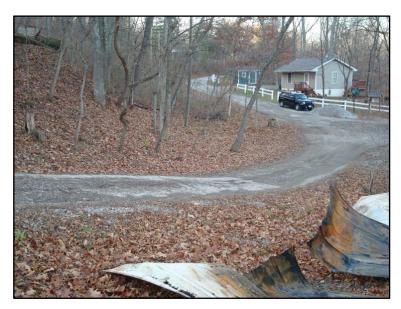
Incident scene (facing North). The victim was near the bottom of the steep incline when struck.

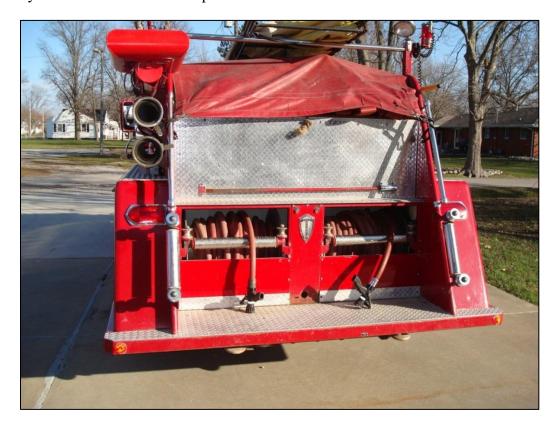
Photo 1. Rear of Brush Truck 12. Note hose reels mounted at the back of the apparatus. The victim likely intended to pull one of these hoses to use to combat the burning structure.

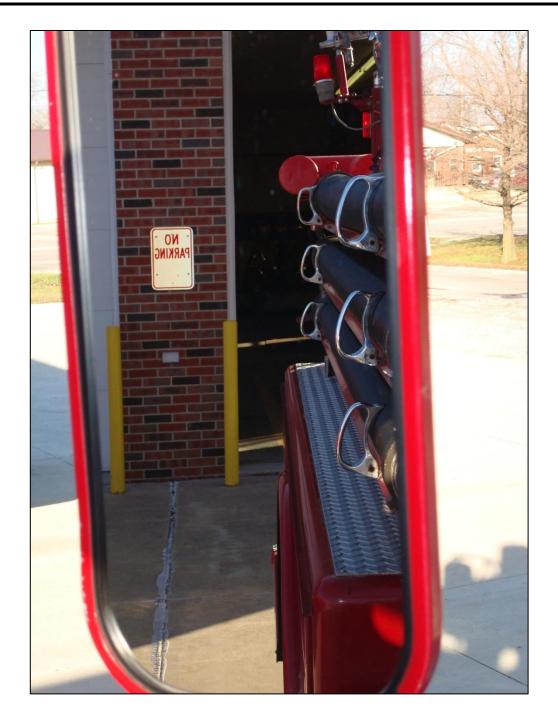
Photo 2. Photo of the driver side mirror on Brush Truck 12. Photo shows the narrow field of view that someone seated in the driver seat would typically see when using the driver side mirror to view the area behind and on the left side of the vehicle.

Recommendation #6: Fire departments, authorities having jurisdiction and apparatus manufacturers should consider evaluating and equipping older fire apparatus and vehicles with current safety equipment to assist drivers during backing operations (e.g., rear view video cameras, automatic sensing devices, additional mirrors, etc.).

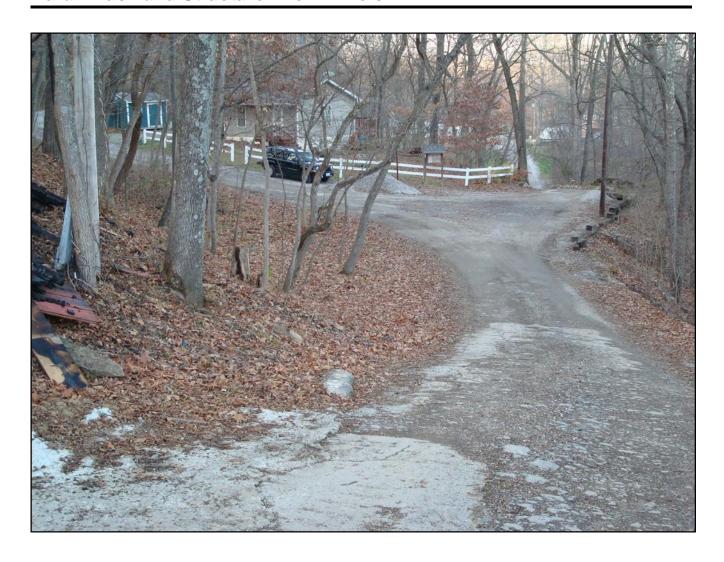
Photo 3. Incident scene looking north. Note the remains of the structure that burned (just visible at the left) and its close proximity to the roadway.

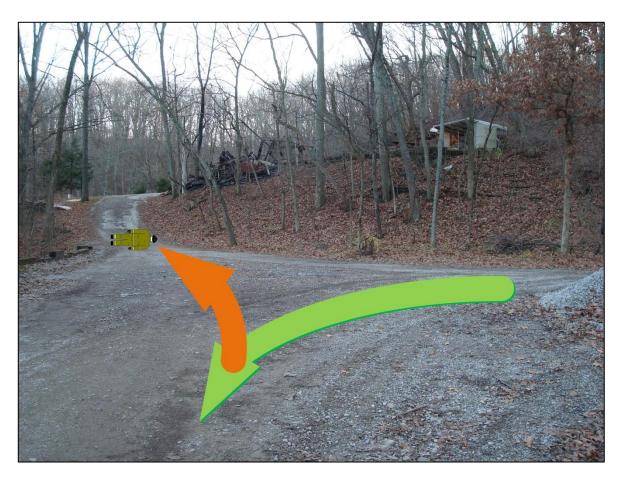
Photo 4. Incident scene facing south. Brush Truck 12 approached the scene from the west (right side of photo), turned left and was attempting to back up the inclined road seen in the background. The remains of the structure that burned can be seen at the top of the hill on the right side of the road. Also note the wooden ties placed along the roadway edge, to protect against driving off the road and going over a steep embankment, visible on the left side of the photo.

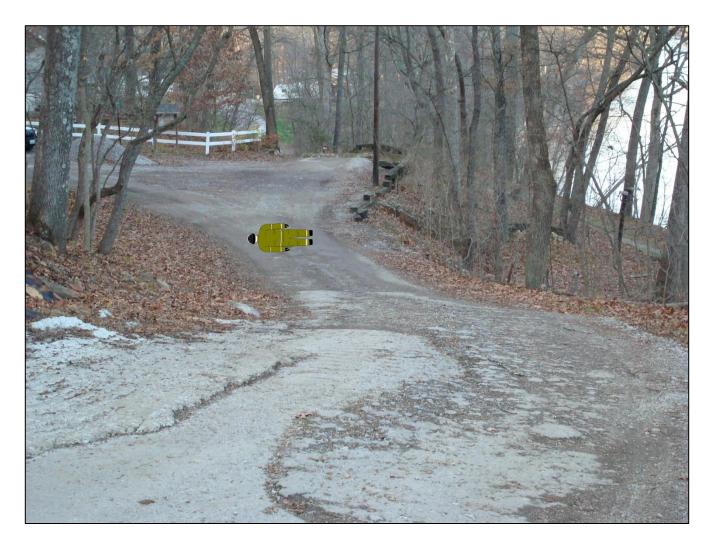
Photo 5. Incident scene looking north. Note the steeply sloping hillside and the river which can be seen at the upper right corner. Also note the wooden ties placed along the roadway edge as a barrier to driving off the road. Approximate location where the fire fighter was struck is noted.

The on-scene ambulance was staged further up this hill.
